Assessments of House Damage from Event Dial Pack and 100 ton AN/FO Test

Interim Report

Prepared by: C. Wilton, URS Research Company

DEFENSE NUCLEAR AGENCY
WASHINGTON, D.C.

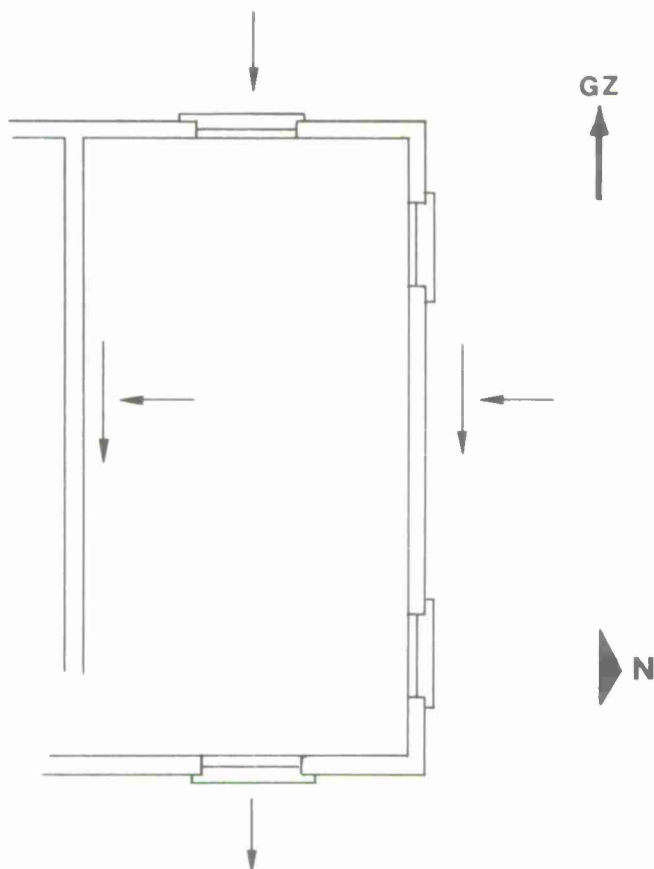
A sketch of the living room is shown below and a description of the damage to each of the walls is given in the following paragraphs.

Both windows were blown inward. There was failure of eighteen 2 by 4 studs out of a total of 26, all in flexure and in the inward direction. About 40 percent of the sheetrock was removed and repair would require complete

replacement (see Figures B-1 and B-2). There was indication of shear motion in the wall; i.e., motion along the seams.

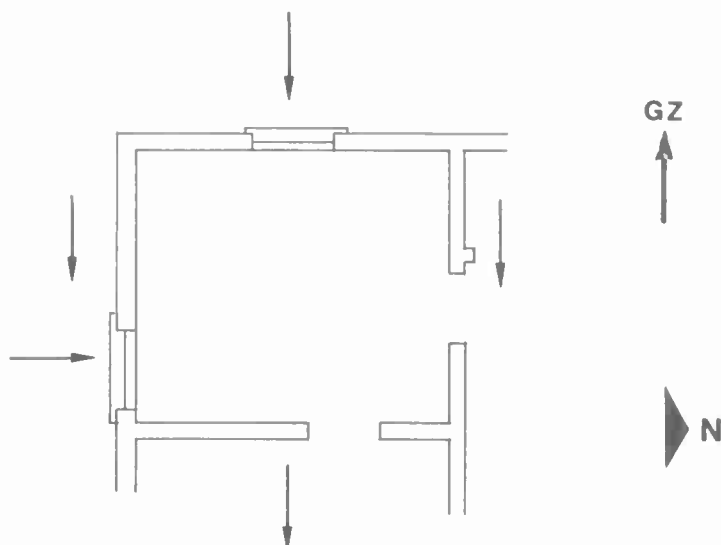
Heavily damaged with window blown in, 90 percent of the sheetrock removal and six of seven studs were broken (Figure B-5).

Numerous shear cracks were noted and there was crushing of the plaster at the intersection of the west and north walls. Approximately 25 percent reconstruction of the wall would be required.

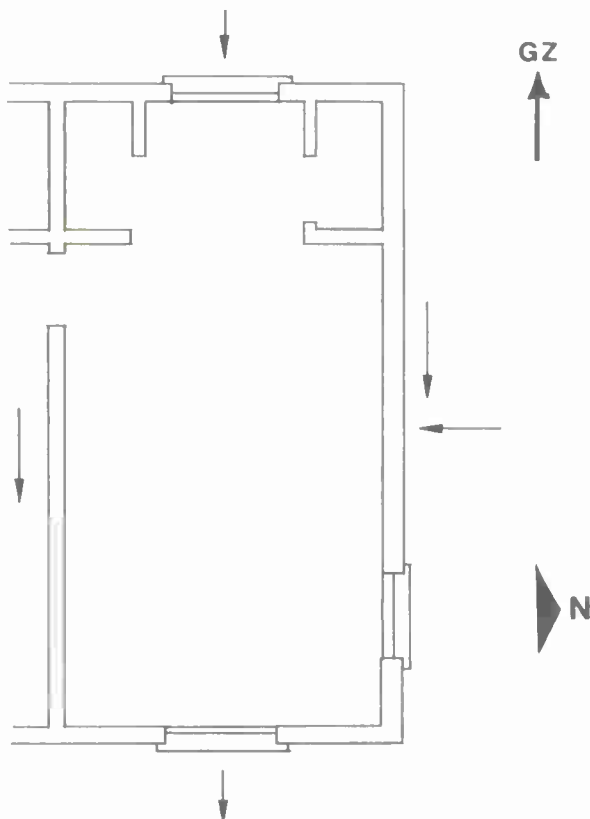
Master Bedroom

Sketched below is the master bedroom showing gross wall motion.

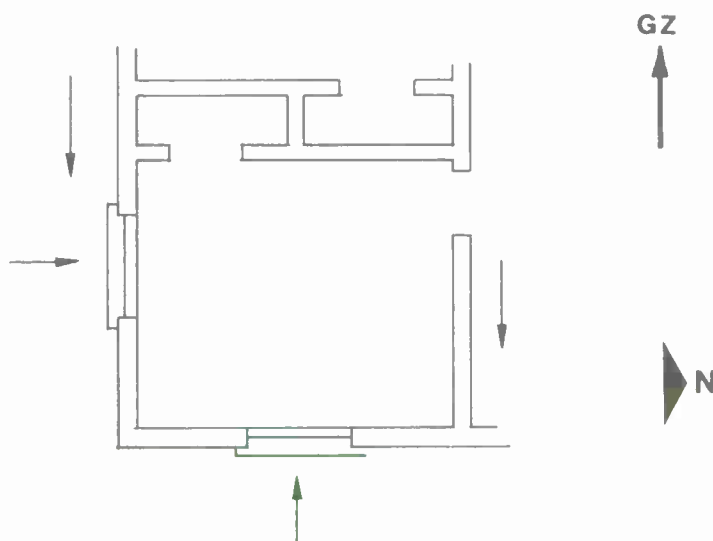
Second Bedroom

A sketch of the second bedroom is presented below.
